LASER CLEANING: THE RESTORATION OF A FIRE-DAMAGED COTTAGE

LEO SEXTON

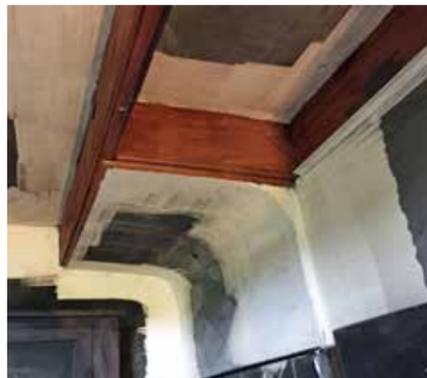
Figure 1: Saving the ceiling battens

In order to avoid this, laser cleaning was employed and was able to remove the soot, both from the painted battens, and the plaster board, (which incidentally saved the whole house from being burned to the ground as the plaster boards have a 20 minute burn-through time) (Figure 1).

During the cleaning process we used our P-Laser Compact CQF 100 W hand-held portable fibre laser (Figure 2) at full power, with a programmable line width of 200 mm and adjusted the focal length to the maximum of 500 mm. This gave the largest spot, thus the lowest energy density per pulse, at a repetition rate of approximately 100 kHz. Extraction was essential as without it, the soot that had been removed would land at another location in the house during the cleaning process. In addition, the operator wore a mask respirator, which was suitable for organic vapours and laser fumes. No heat was generated during the cleaning process. The laser wavelength was absorbed into the black soot on the battens and walls and reflected off the white paint. The soot was also removed from the brown painted battens, which was thick enough to ablate a few microns of brown paint. The battens were ready for immediate repainting afterwards.

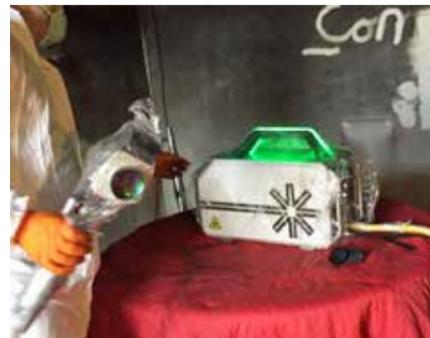
Figure 2: The 100 W Compact laser. Transparent film was wrapped around the laser and fibre delivery cable to protect them from the soot.

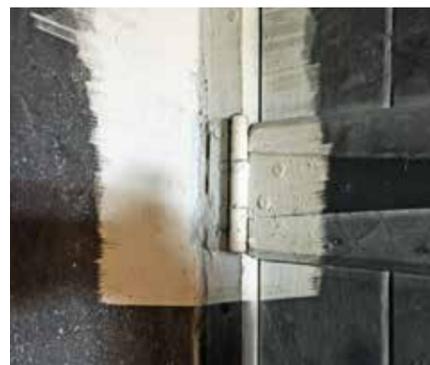
The same was true for removing the black soot on a painted door. Here the white paint, just like on the walls, reflected the beam completely. Figure 3 shows that all the soot on the wall, hinge and door was removed. The common feature for the walls, woodwork and metal hinges was that they were all painted white. White paint

Figure 3: The laser beam was reflected off the white plaster boards and white painted walls, while at the same time removing the soot.

can be difficult to remove using laser cleaning. Generally darker colours tend to absorb the beam more easily than lighter colours, although this is more of a guide than a rule. It is the chemical composition of the pigments in the paint that ultimately determines the success of the ablation.

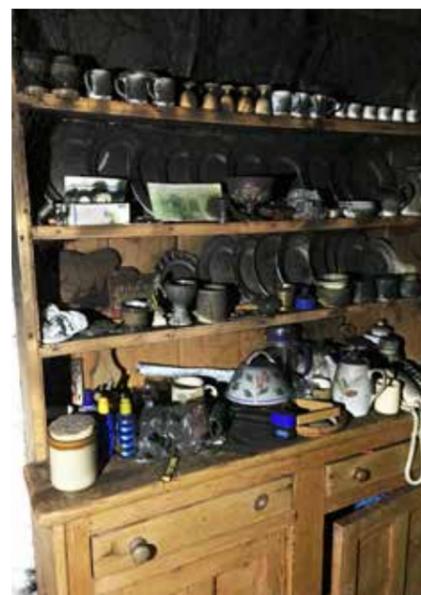
Most items on the kitchen dresser were badly damaged, as shown in Figure 4. Even the contents inside the drawers and cupboards were covered with fine particles of soot. Laser

Figure 4: Smoke damaged items on kitchen dresser.

cleaning could be carried out any metal or ceramic artefact on the dresser. The Delft pottery on the dresser was old and more ornamental than practical. Normal washing detergent was not strong enough to break down the hydrocarbon chemical bonds in the soot. We were not permitted to use anything stronger than domestic washing-up detergent which had to be eco-friendly.

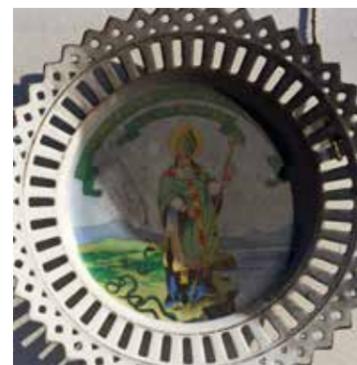
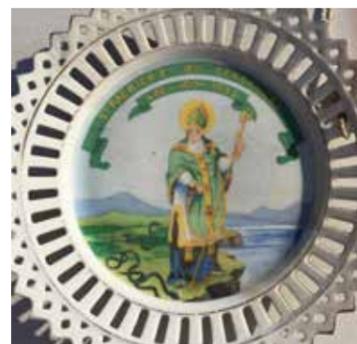
Figure 5: Before and after images of cleaning Plate 1.

pottery before and after laser cleaning. The plate depicting St. Patrick (Figure 5) was laser cleaned using the same parameters employed for removing the soot from the battens and plasterwork. The image of St. Patrick and the text on the plate were printed over the top of the glaze and it appears that some of the paint was removed by the action of the laser. Perhaps with softer parameters, i.e. 30% energy per pulse, instead of 100% (1 mJ), this may not have been the case.

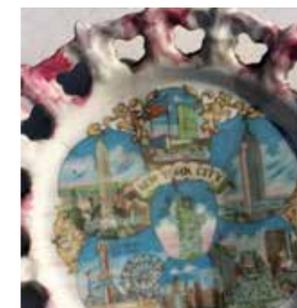
We changed the profile of the beam from a line to a circular scan for the next plate (Figure 6). The words "New York City" were slightly faded by the action of the laser because once again the print was on top of the glaze. Round the circumference of the plate there were splashes of red paint. None of this faded because the red paint was under the glaze and thus protected against the laser beam.

Figure 6: Before and after images of cleaning Plate 2.

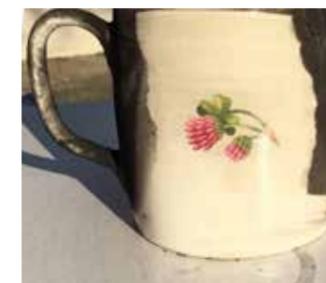
The milk jug in Figure 7 was restored to a usable condition. Initially the pattern on the jug could not be seen, but with one sweep of the beam it was revealed. We did hear some of the glaze started to "ping" and tiny micro cracks were visible. The jug already exhibited quite a large number of mini cracks in the glaze and the beam may have been diffracted into these cracks.

Figure 7: Before and after images of cleaning a milk jug.
